FINAL REPORT

Low Temperature Cure Powder Coatings

ESTCP Project WP-200614

Wayne Patterson
David Piatkowski
Science Applications International Corporation

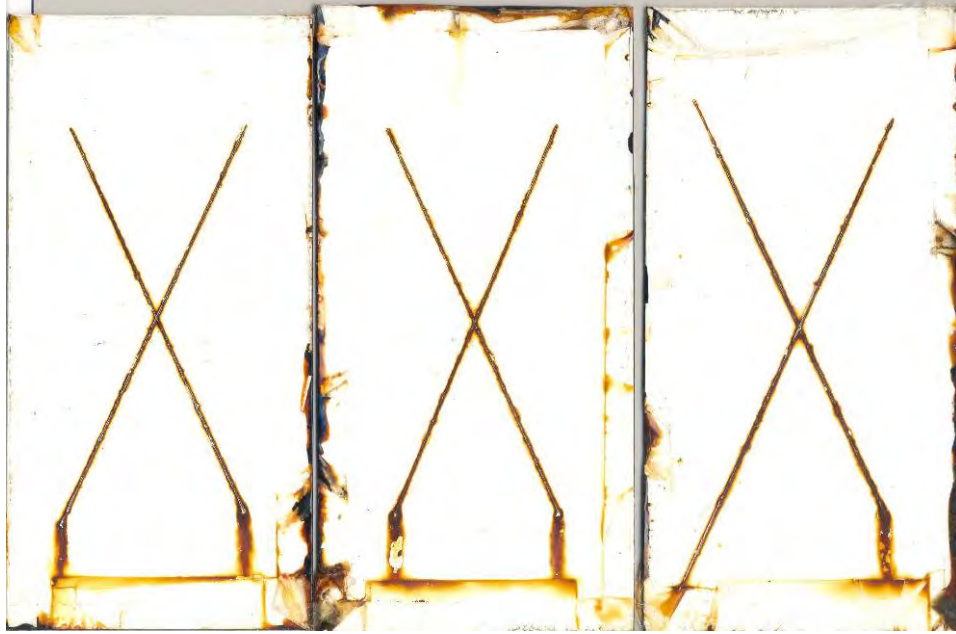
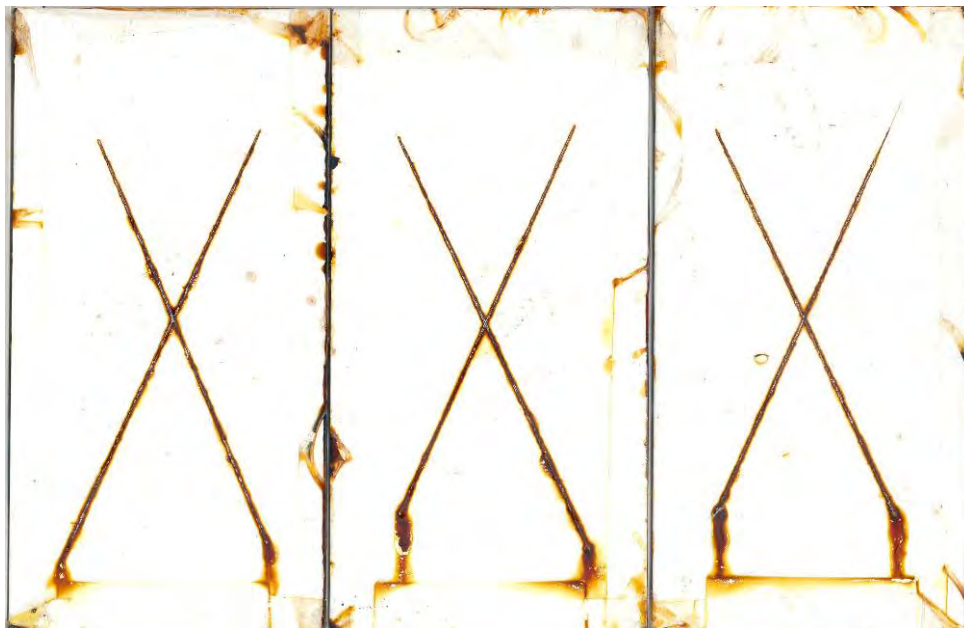
Figures 17 through 22 are of the test coupons following the SO₂ corrosion resistance testing.

SO₂ corrosion resistance test results confirmed that LTCPC performs in a similar fashion as the baseline coating stack-ups when prepared and tested in a production-like environment. Evaluation of the selected aluminum coupons resulted in acceptable SO₂ corrosion resistance (as defined by the JTP) for only the Alodined 2024-T3 LTCPC and control-coated coupons. All remaining aluminum specimens suffered major blistering near the scribed regions. Stakeholder discussion produced a consensus that poor surface pretreatment was likely to blame for the test failures of low copper content aluminum alloys while the 2024-T3 specimens passed. From a

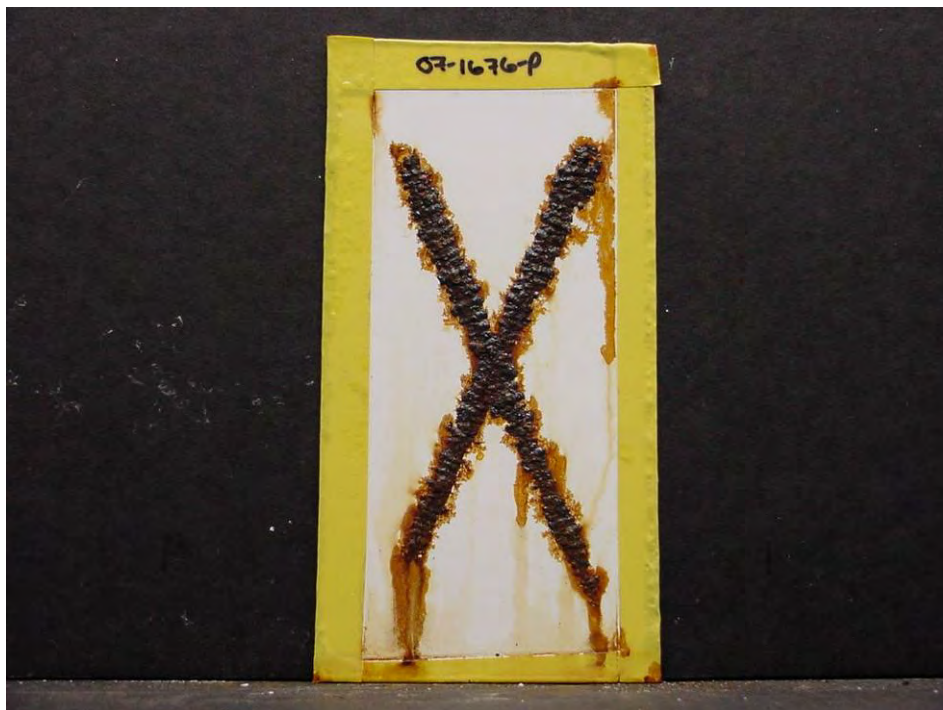
Figures 23 through 26 are of the test coupons following the cyclic corrosion resistance testing.

Overall cyclic corrosion resistance test results confirmed that LTCPC performs in a similar fashion as the baseline coating stack-ups when prepared and tested in a production-like environment. The Alodined 2024-T3 Alclad coupons outperformed the baseline MIL-PRF-

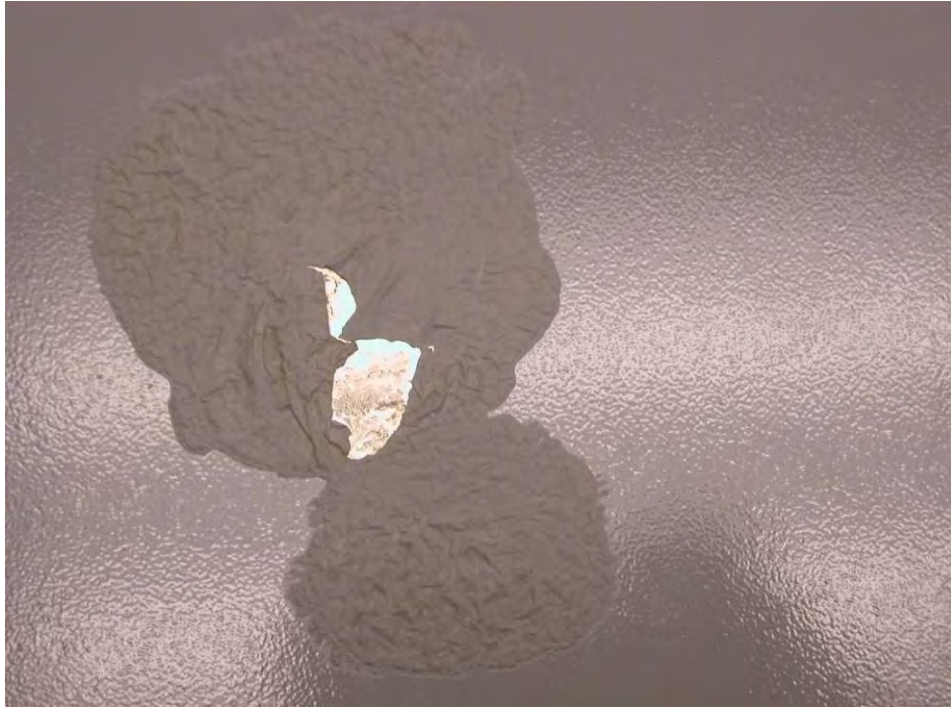
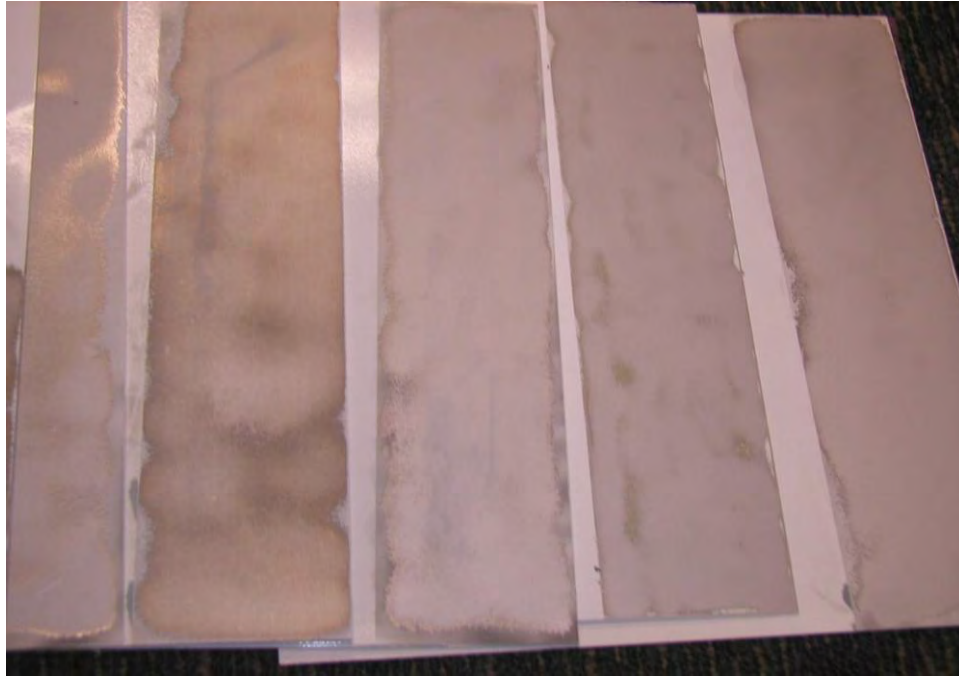
Figures 33 and 34 are of the test coupons following chemical and mechanical stripping. As can be seen for the chemical stripper test, an amount of the liquid was placed on a coated 12 in. x 12 in. panel. For a successful test, the coating softened and lifted from the substrate (in some cases, light fingertip abrasion could flake off the coating). For the mechanical stripping evaluation, a single three inch strip was media blasted on each panel.

A comparative study of LTCPC and control coating removal using a non-methylene chloride stripper (benzyl alcohol peroxide) confirmed the product's acceptability. Reported efficiencies for the chemical stripper used on each of the prepared aluminum and steel specimens followed the guidelines provided within the JTP. The benzyl alcohol peroxide's ability to remove 100% of the LTCPC from each substrate met the defined efficiency measures for chemical strippability. With regards to mechanical strippability, Type V plastic and GPX media blasting adequately removed LTCPC from each substrate well within the study's 90 minute time limit.

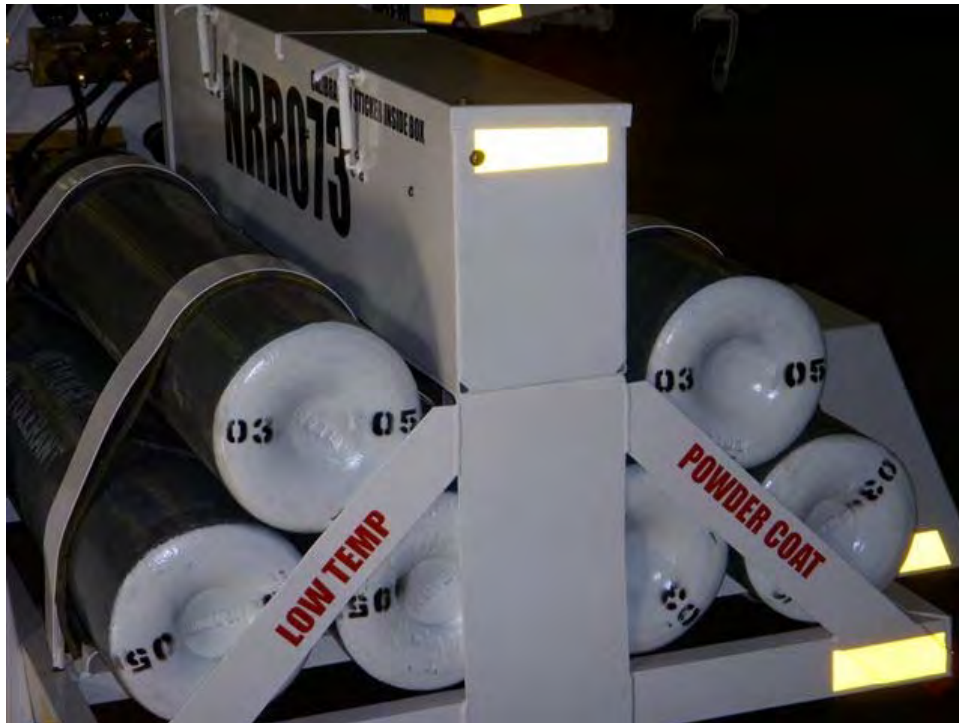
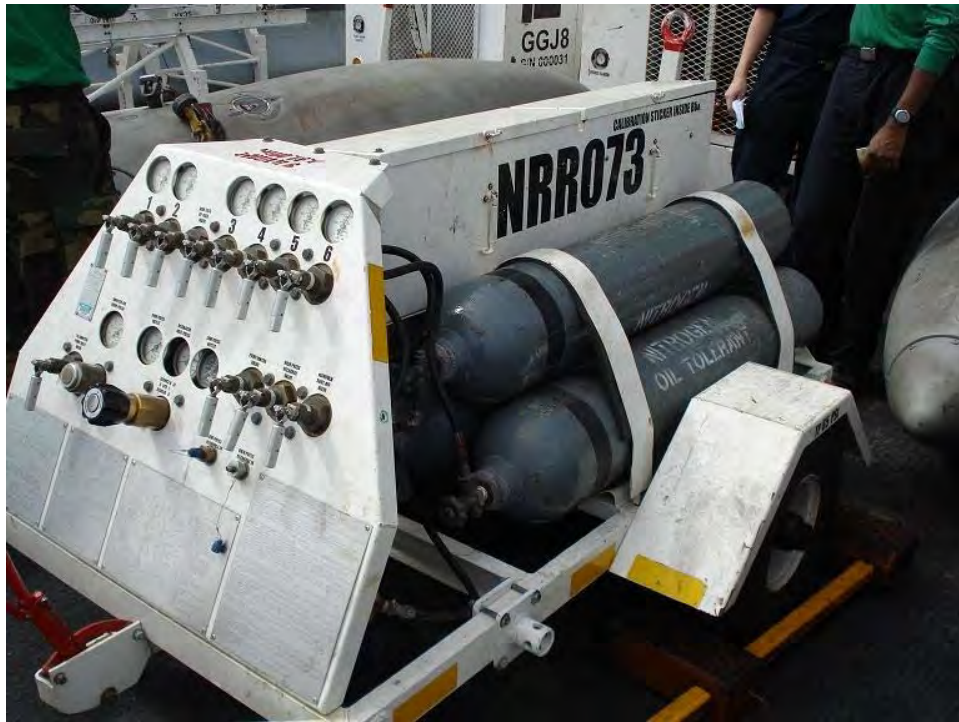
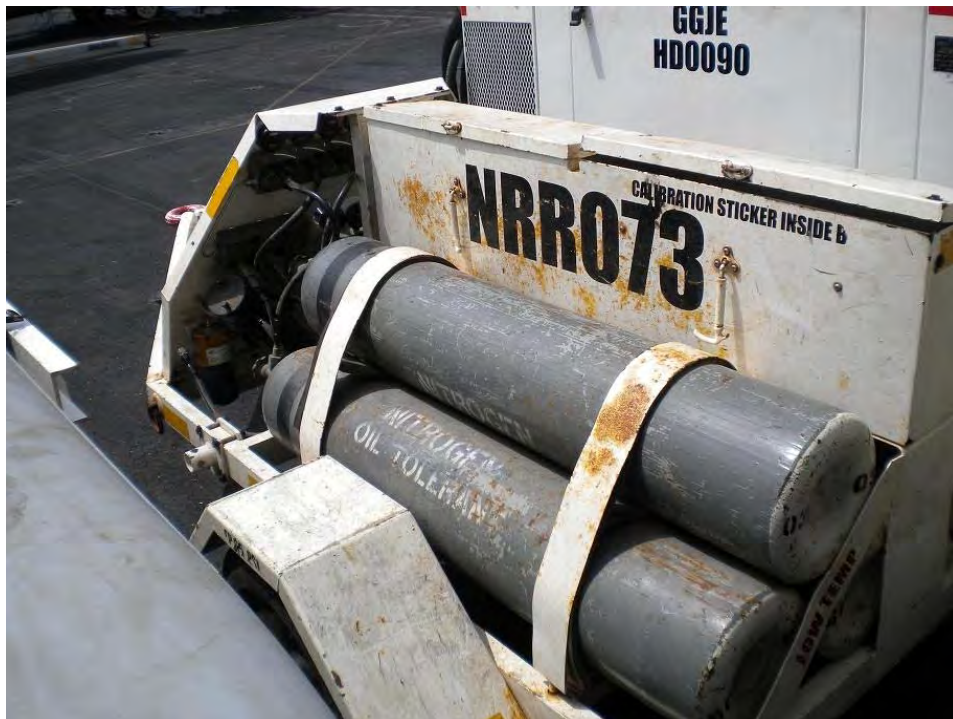
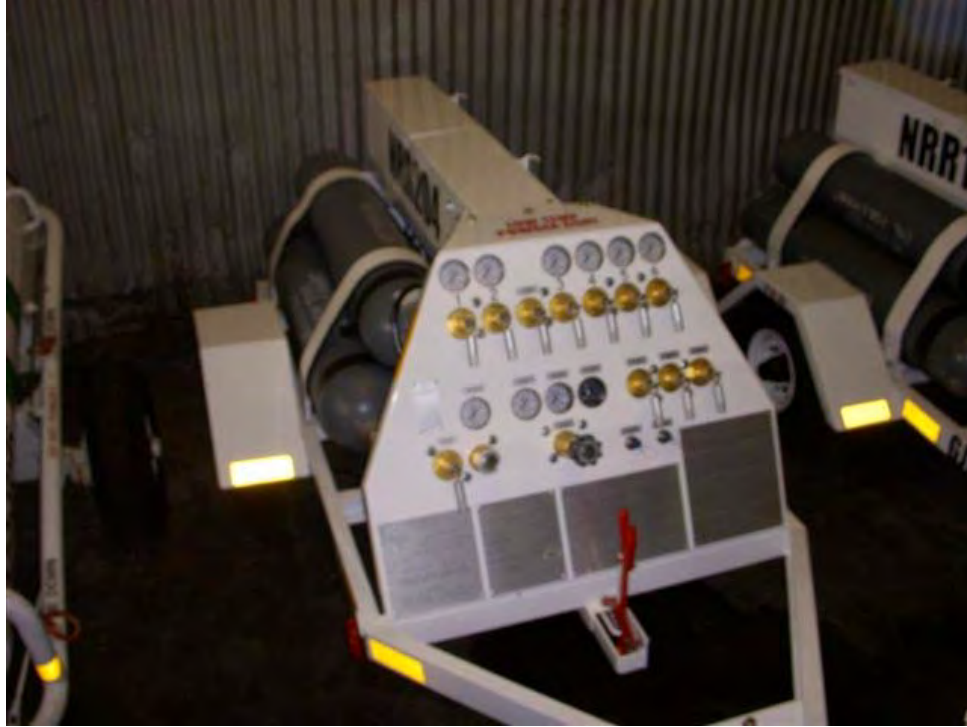
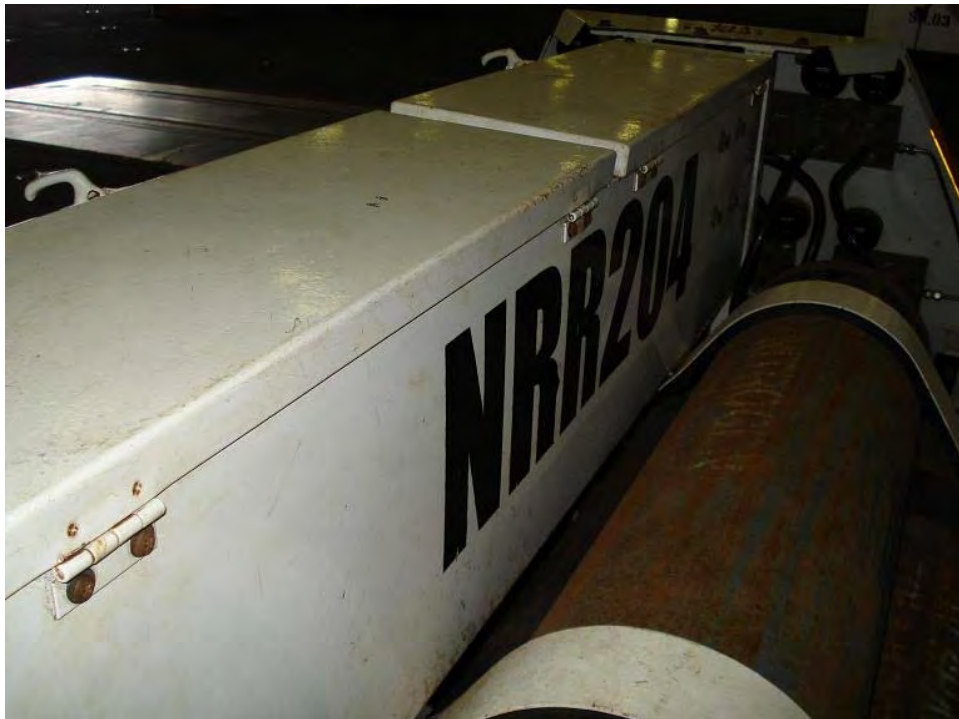
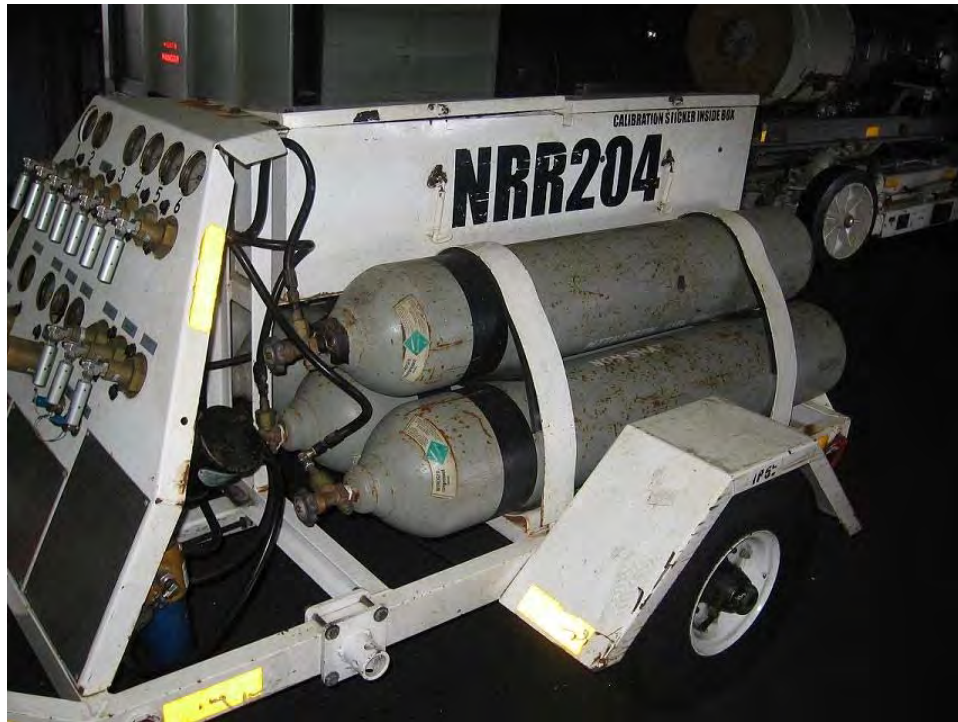
The following photographs were taken prior to deployment and over the course of the FSE aboard USN aircraft carriers.

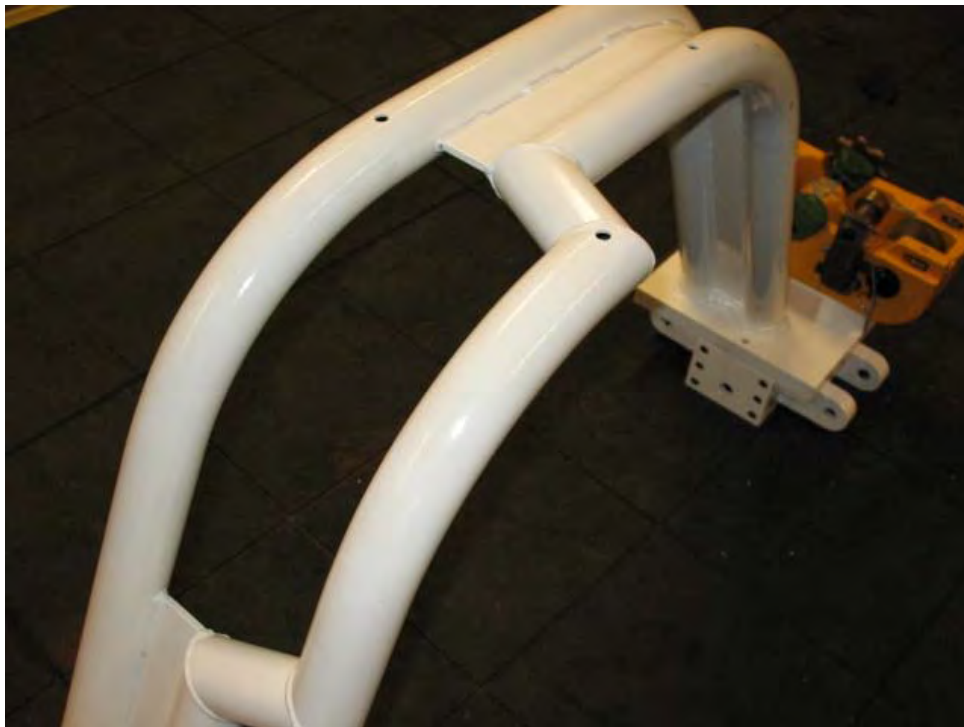
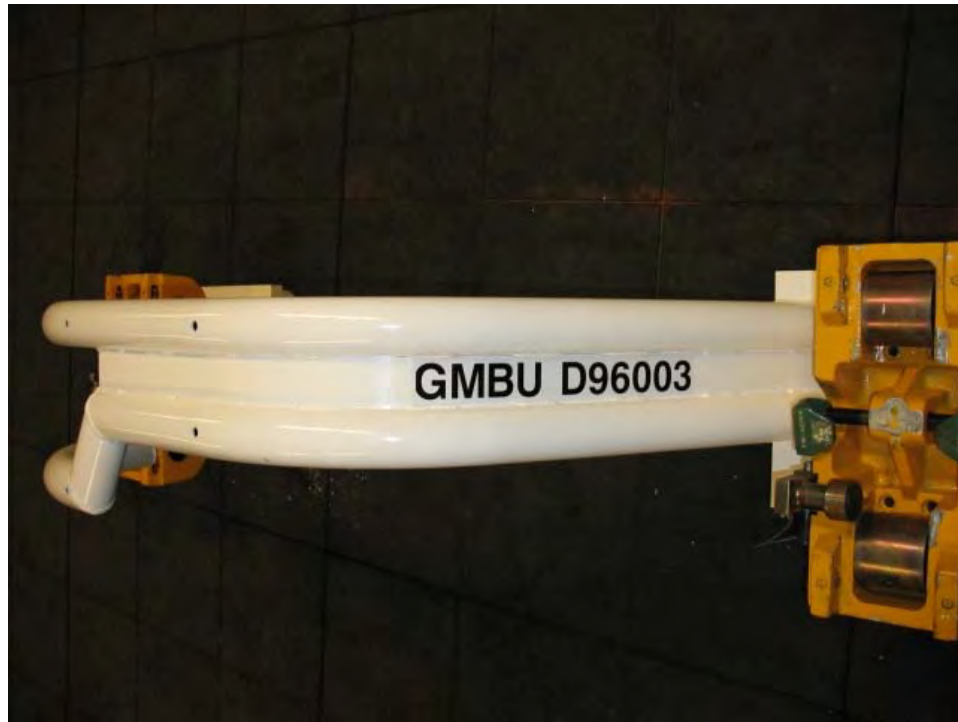
The following photographs were taken prior to use during the FSE deployment at FRCNW.

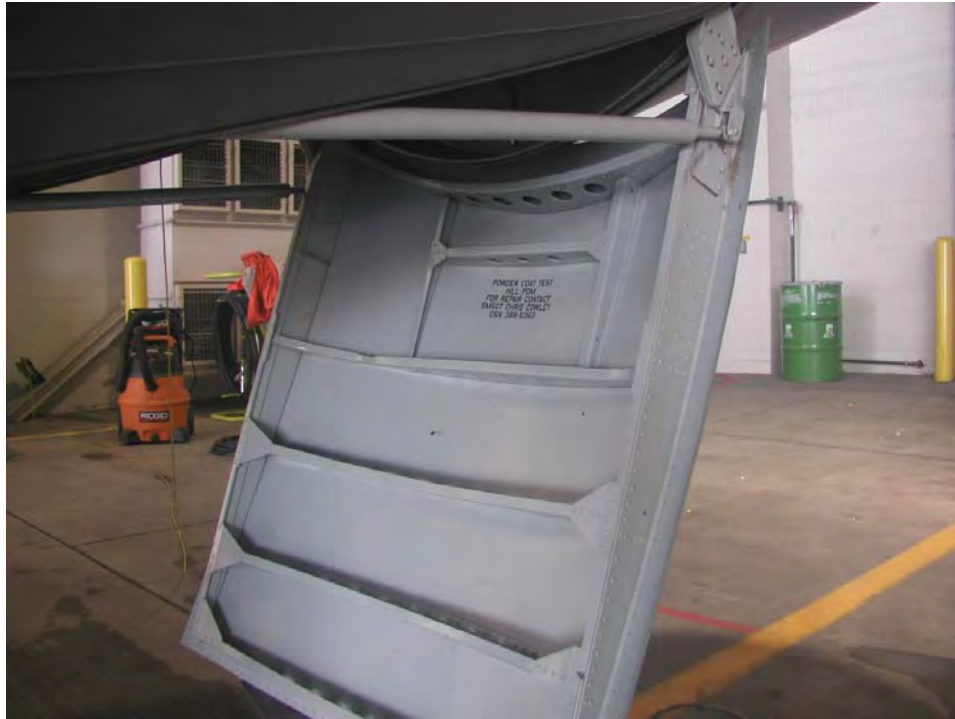
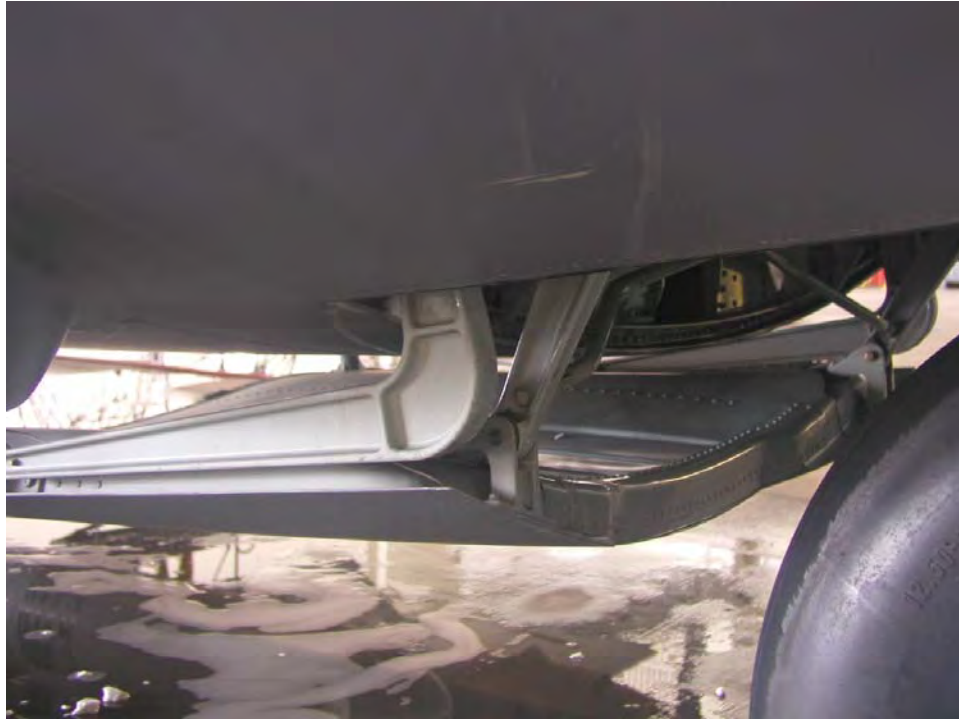
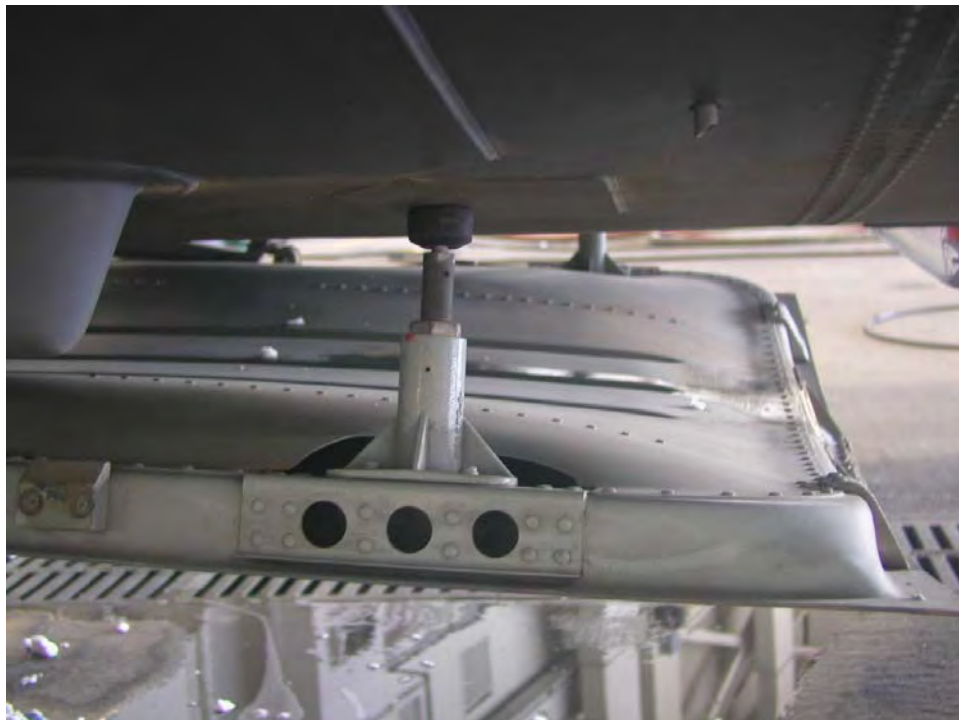
The following photographs were taken during the course of the FSE deployment to various theaters of operation.

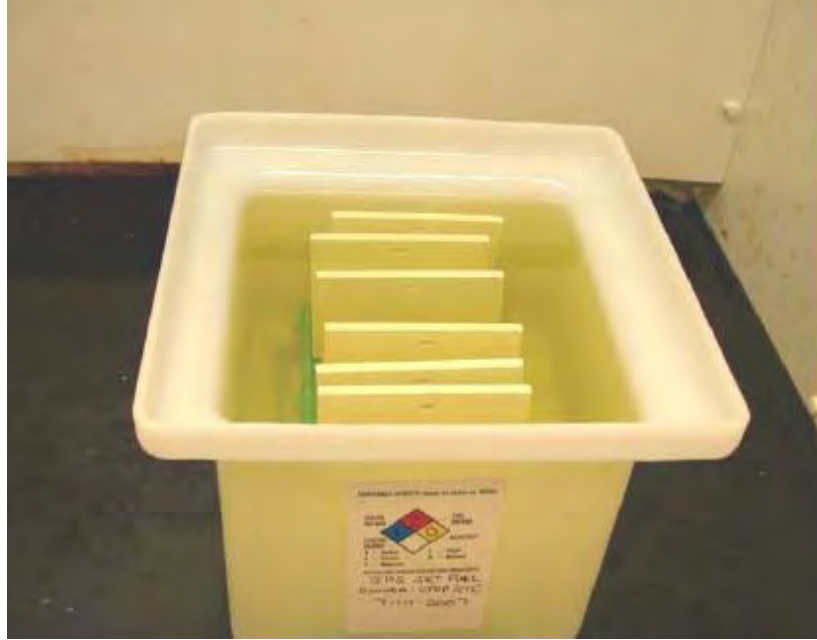
Figures 53 through 55 are of the immersion tanks utilized for this evaluation.

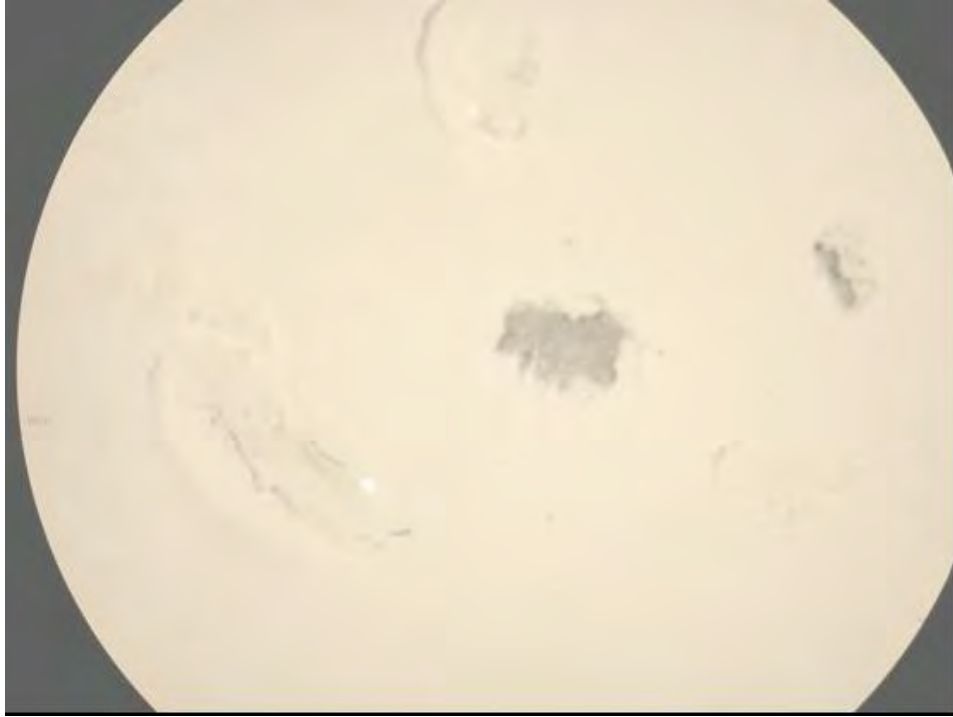
The use of a gravelometer to determine chipping resistance produced specimen coating damage comparable to the two coupons shown in Figures 56 and 57 under 10X magnification.

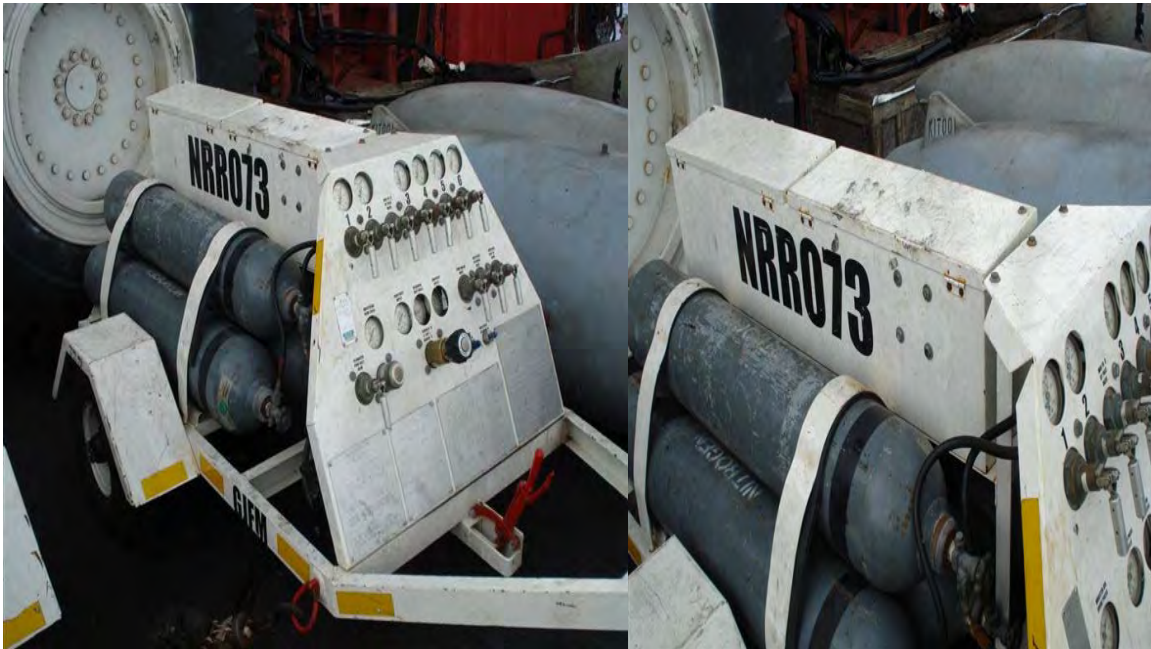
Comments and observations: UNIT HAS A LITTLE CORROSION ON THE BOXES, AROUND THE HINGES MINOR CORROSION. PAINT IS HOLDING UP WELL.

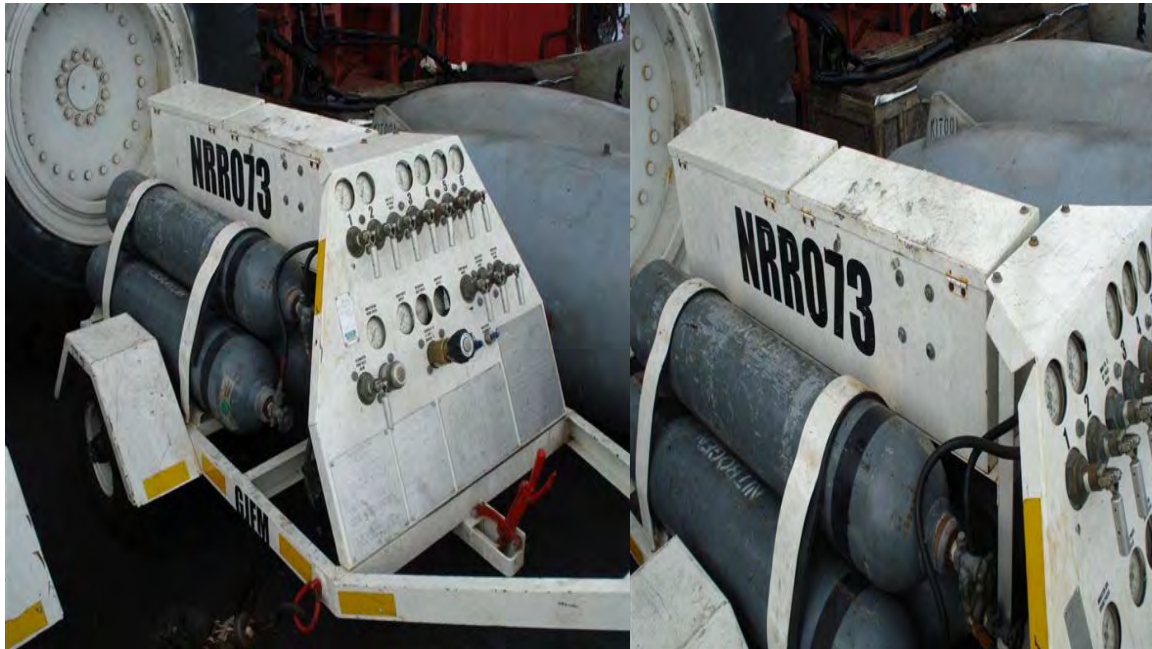
Component Serial No. NRR073

Comments and observations: UNIT HAS A LITTLE CORROSION ON THE BOXES, AROUND THE HINGES MINOR CORROSION. PAINT IS HOLDING UP WELL.

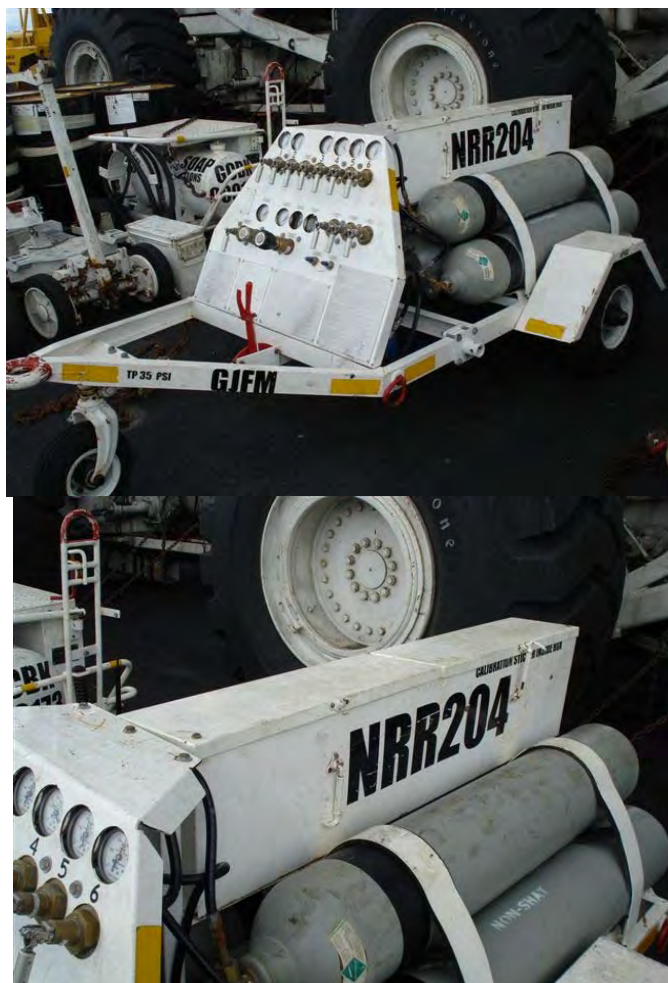
Comments and observations: CONDITION OF UNIT IS WITH STANDING FLIGHT DECK USE ON A DAILY BASIS. MINOR SCRATCHES ON FENDERS AND MAIN FRAME BUT OVER-ALL POWDER COATING IS STILL GOOD. NITROGEN BOTTLES HAVE BEEN REPAINTED DUE TO SURFACE CORROSION.
